Compliant Foil Seal Investigations

Margaret Proctor

2003 NASA Seal/Secondary Air System Workshop

November 5-6, 2003

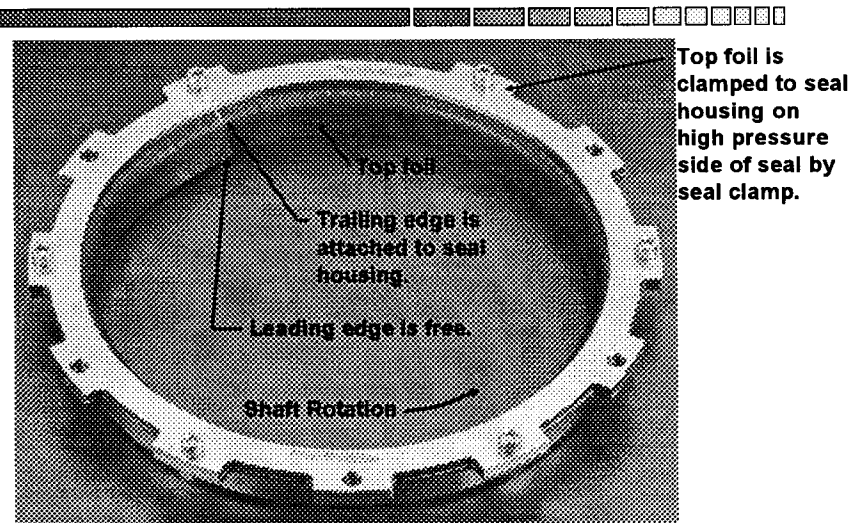
Mohawk's 8.5 inch Foil Seal Prior to Test

This foil seal is an extension of MiTi's foil bearing technology. The foil seal is essentially a foil bearing that uses a pair of top foils with slotted extensions to block the axial flow from passing thru the bump foils located behind the top foils. The two top foils are clocked to each other so that the extension tabs of one top foil block the slots of the other. The trailing edge of the top foil is fixed to the seal housing and the leading edge is free. Rotor rotation is counter clockwise looking from the high pressure side. The top foil is coated with MiTi's Korolon 800 coating.

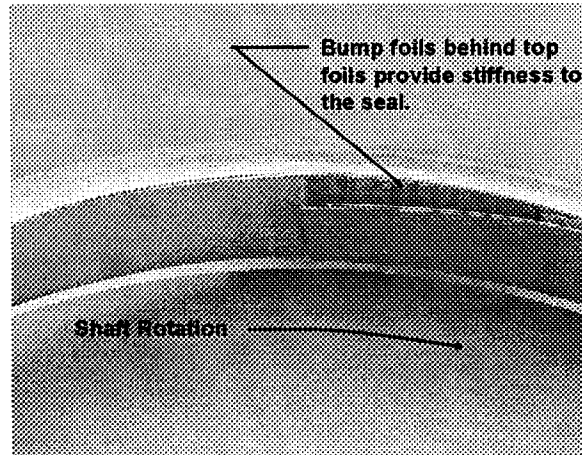
Down Stream Edge of Foil Seal

The bump foils can be seen behind the top foil in this view of the downstream side of the seal near the leading edge. When the seal is installed over the rotor od.

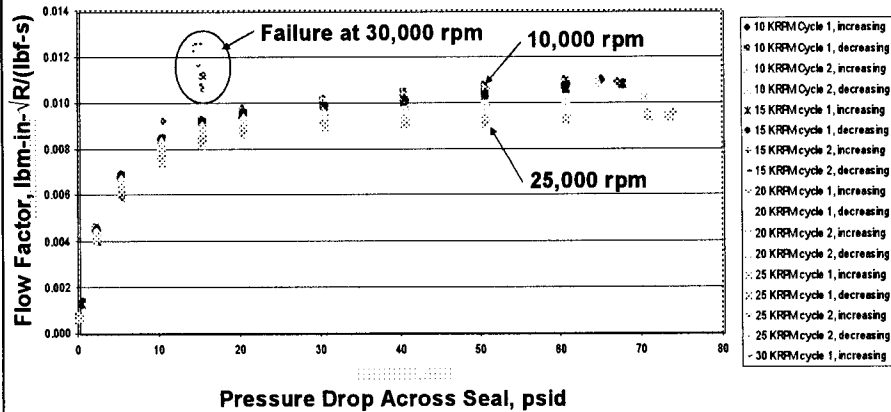
Leakage Performance of 8.5 inch Foil Seal

This is a plot of the seal leakage flow factor versus pressure drop across the seal obtained during the performance test. For all speeds the flow factor increases with increasing pressure differential until about 25-30 psid where it levels off indicating that the flow is choked. The flow factor decreases as speed increases due to reduced clearance caused by centrifugal growth of the rotor. During the failure event at 30,000 rpm and 15 psid the flow factor increased substantially and rapidly. This sudden increase in flow factor indicates an opening of the seal clearance caused by either loss of the seal coating or wear of the seal top foil.

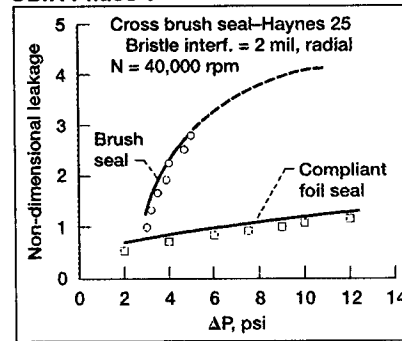
Foil Seal and Brush Seal Leakage Data
2.84 in. Dia. Journal; 68 °F
SBIR Phase 1

From the previous chart we see that the flow factor for the 8.5 inch foil seal leveled out between 0.009 and 0.011.

Previous testing at NASA has shown that finger and brush seals have flow factors of 0.004 to 0.006.

MiTi previously tested a 2.84 inch foil seal and found its leakage performance to be much better than a brush seal.

The leakage performance of the 8.5 inch foil seal is about twice that of a brush or finger seal. Since this is counter to previous findings at smaller diameter seals, it is concluded that there are some scale up issues that need to be addressed.

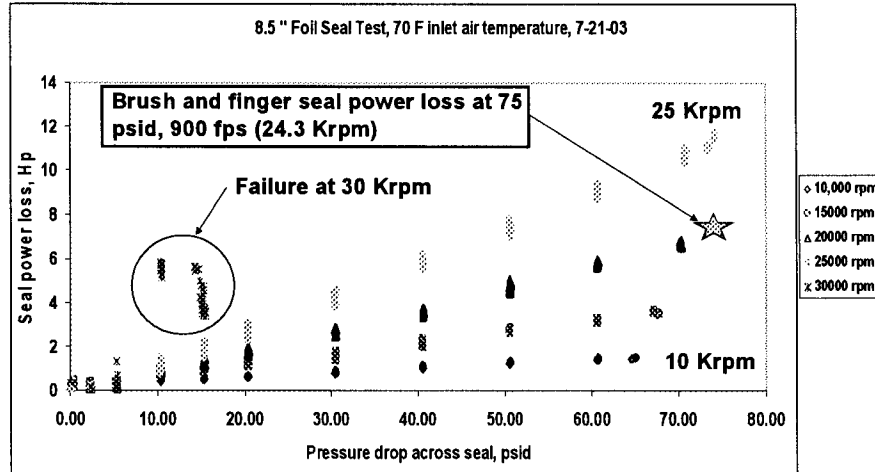
Power Loss of 8.5 inch Foil Seal

This is a plot of the measured 8.5 inch foil seal power loss versus pressure drop across the seal for each speed tested. A torquemeter was used to measure the total torque of the seal test rig with the seal installed. The tare torque of the seal test rig without a test seal installed is subtracted from the total torque to derive the seal torque. The seal power loss is computed as the seal torque multiplied by speed. The seal power loss increases with speed and with pressure differential.

Noting that the seal power loss of the 8.5 inch foil seal at 25,000 rpm or 927 ft/s and 75 psid is 11-12 Hp and comparing it to previously published data for the finger and brush seal at 1200 F inlet air temperature, 900 ft/s and 75 psid which had a seal power loss of 7.5 to 8 Hp, it is concluded that the 8.5 inch foil seal tested has a higher power loss than a brush or finger seal.

The seal power loss at 30,000 rpm and 15 psid was higher than one might expect based on the data for lower speeds. Also the power loss at 30,000 rpm and 10 psid was quite high and indicates rubbing was occurring at that point.

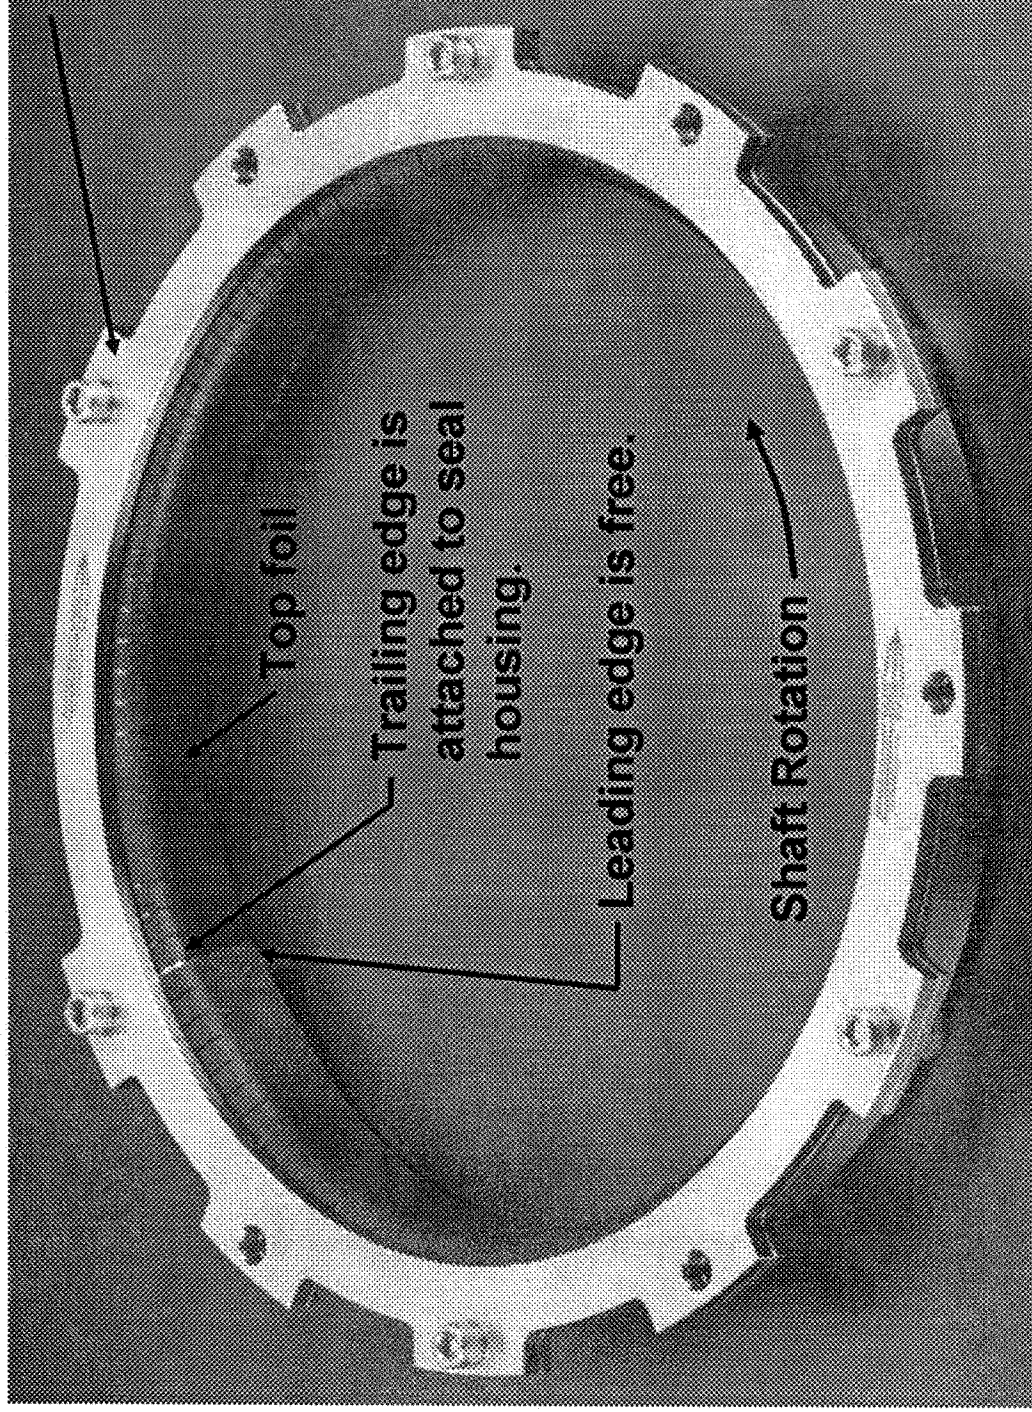
Mohawk's 8.5 inch Foil Seal Prior to Test

Top foil is clamped to seal housing on high pressure side of seal by seal clamp.

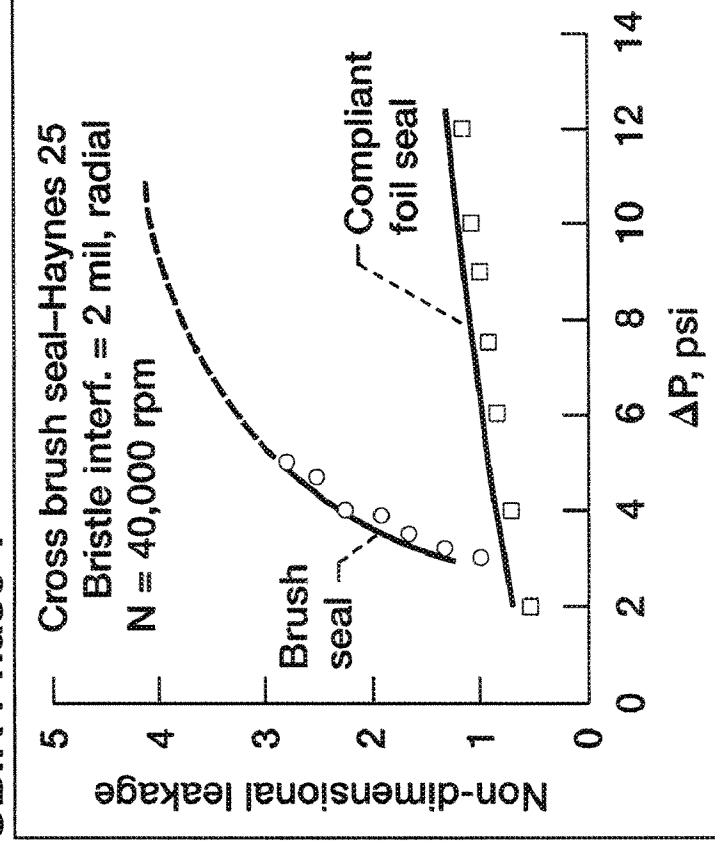
Foil Seal and Brush Seal Leakage Data
2.84 in. Dia. Journal; 68 °F
SBIR Phase 1

- The 8.5 inch foil seal flow factor levels out between 0.009 to 0.011.
- Previous testing has shown finger and brush seals to have flow factors at 0.004 to 0.006.
- MiTi previously tested a 2.84 inch foil seal and found its leakage performance to be much better than a brush seal.
- The leakage performance of the 8.5 inch foil seal is about twice that of finger or brush seals. Since this is counter to previous findings at smaller diameter seals, it is concluded that there are some scale up issues that need to be addressed.
